Stoltz Bluff Sediment Remediation – Sept. 2017 Maintenance Project

Stoltz Sediment Containment Overwhelmed by Major Debris Torrent from 'Clearwater' Creek Gully (late March 2017)

STOLTZ BLUFF SLOPE HAZARD ASSESSMENT	MEMORANDUM
TO: BC Conservation Foundation	DATE: September 12, 2017
ATTN: James Craig	FILE: 17-4
SUBJECT: 2017 WORK PLAN	COPIES: Cowichan Watershed Board DFO

STOLTZ BLUFF STABILIZATION

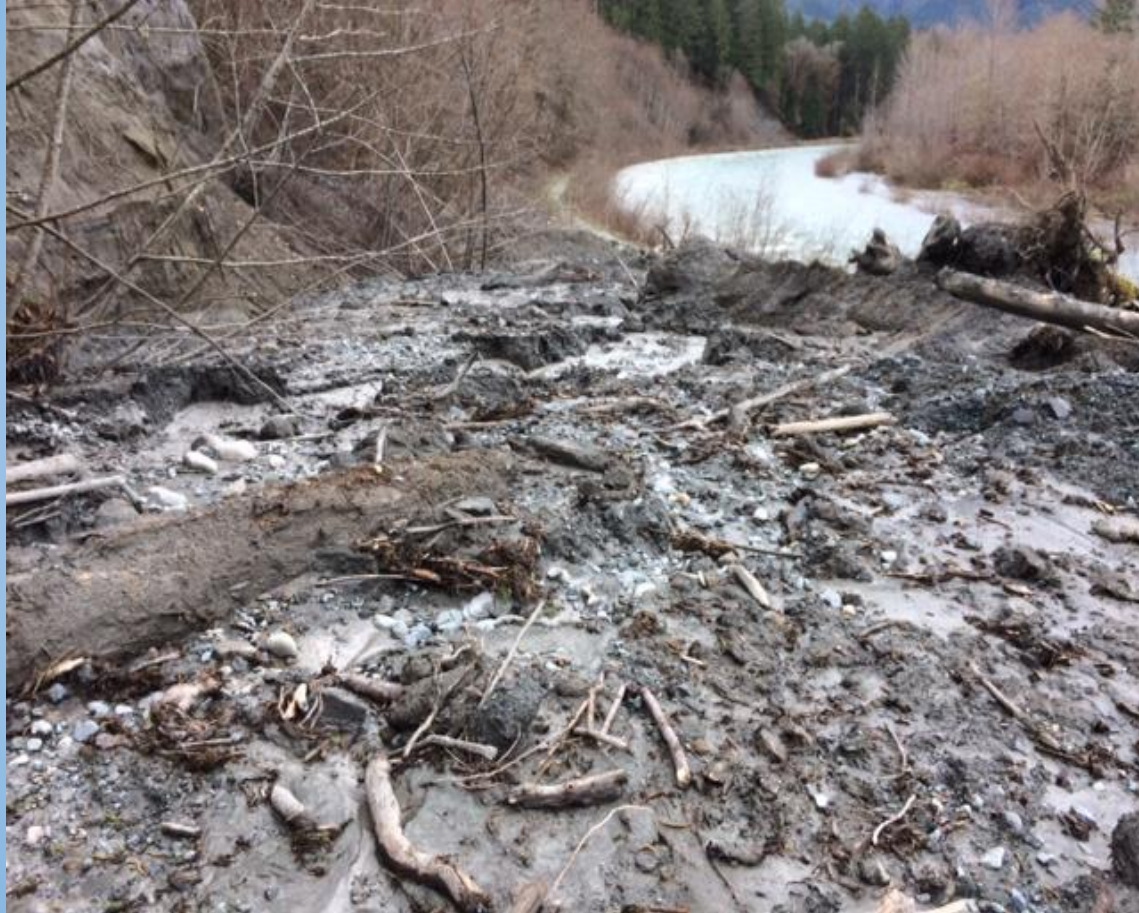
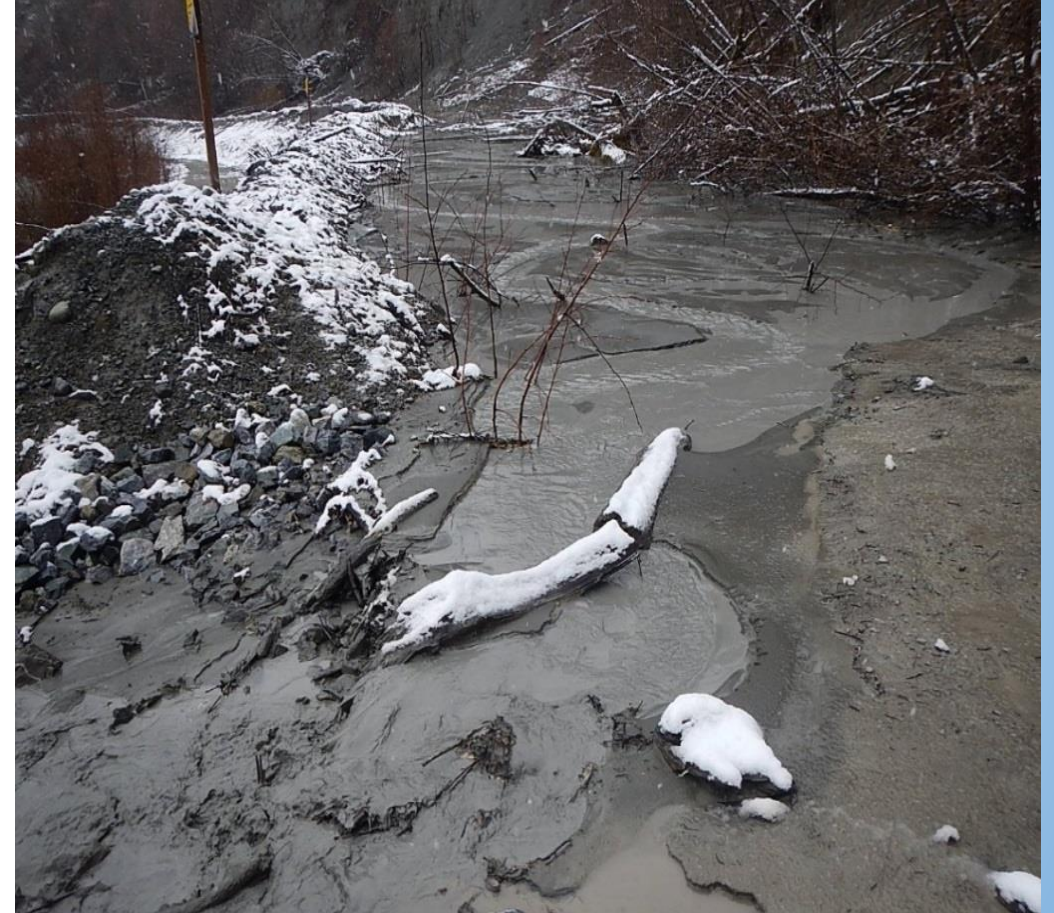
Rest of Sediment Containment Pond Network at Capacity April 2017

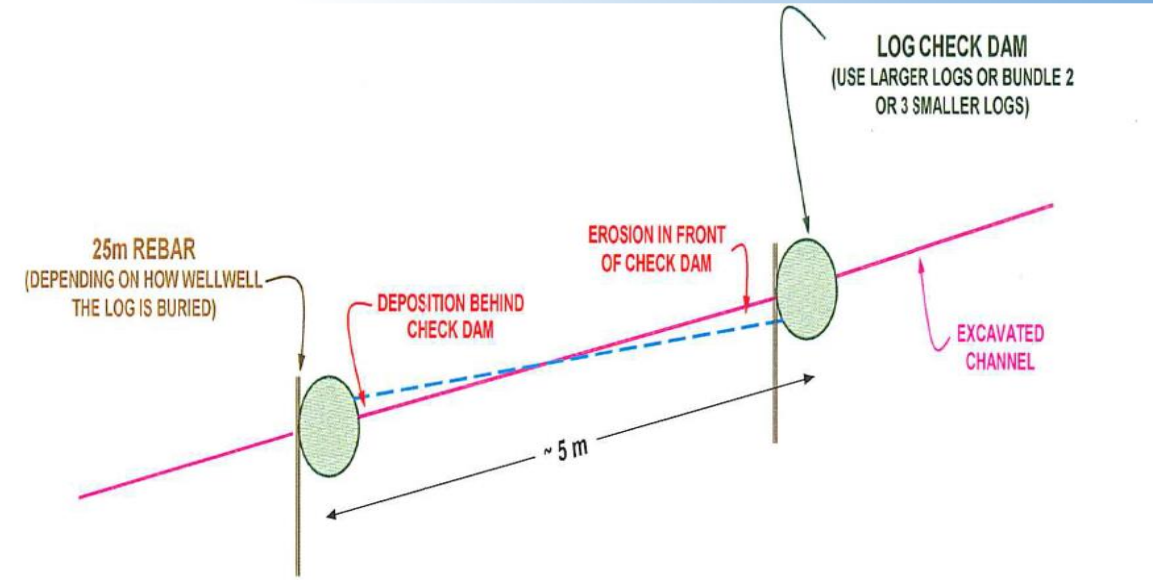
FIGURE 2.
MITIGATION PLAN MAP
Scale 1:1,000

Maintenance of existing creek bed elevation will help with sediment retention and gradual 'shallowing' of gradient for increased channel resilience

1. Ensure logs are well buried at both ends to prevent it from being washed downslope (see cross-sections). Sidewall failures should increase burial before peak winter flow.
2. Initially bury at least 50% of log diameter below the channel grade. The stream will tend to erode immediately downstream of the log and deposit on the upstream of the next log.
3. If needed, rebar can be installed for additional anchorage on the downstream side of the logs. Use 25M bars minimum 1.2 m long, driven roughly 2 m o/c.

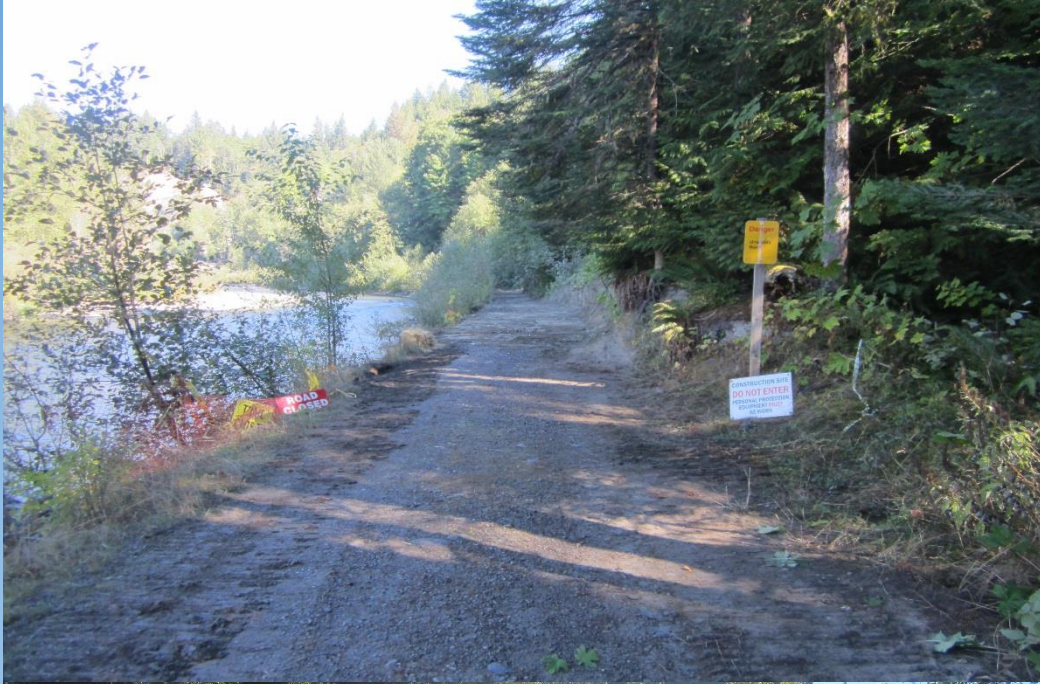
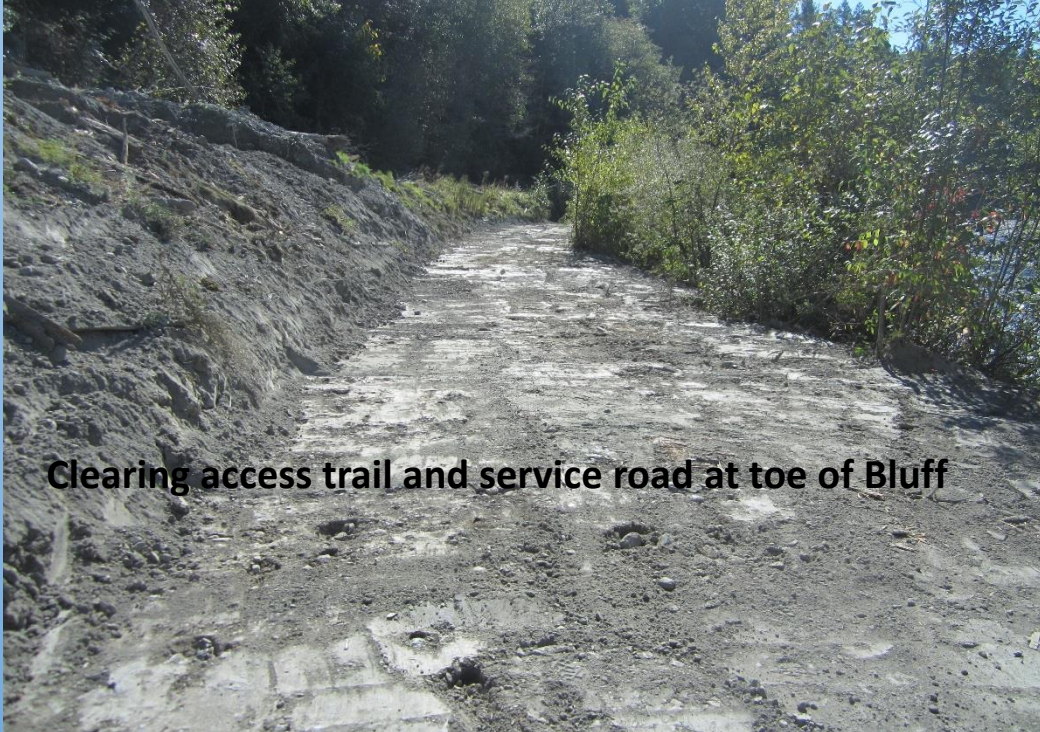
Clearing access trail and service road at toe of Bluff

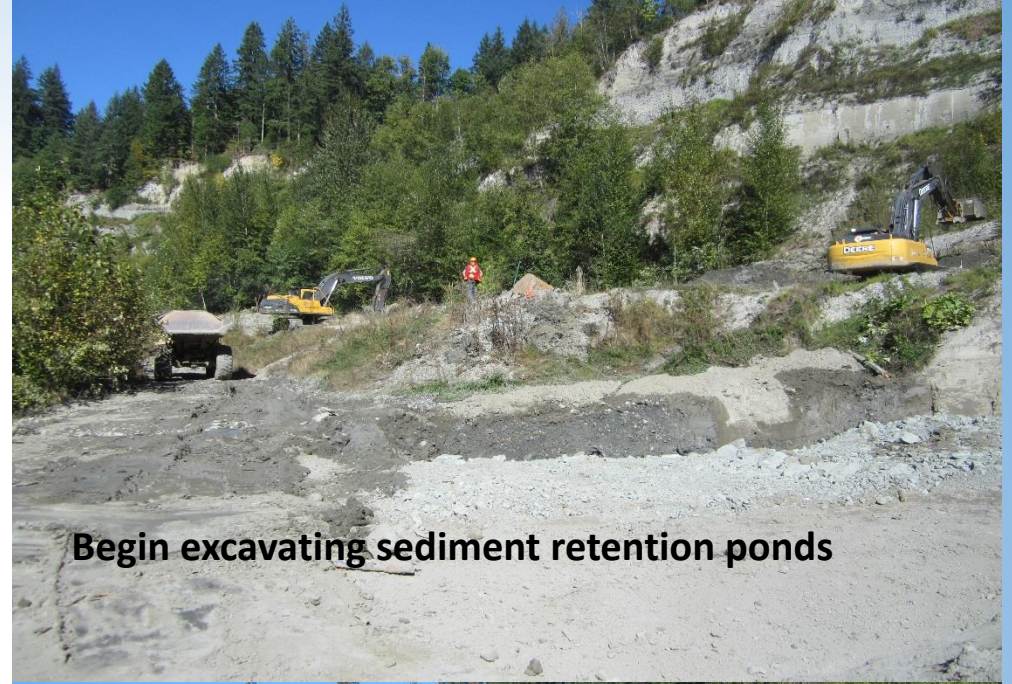
Begin excavating sediment retention ponds

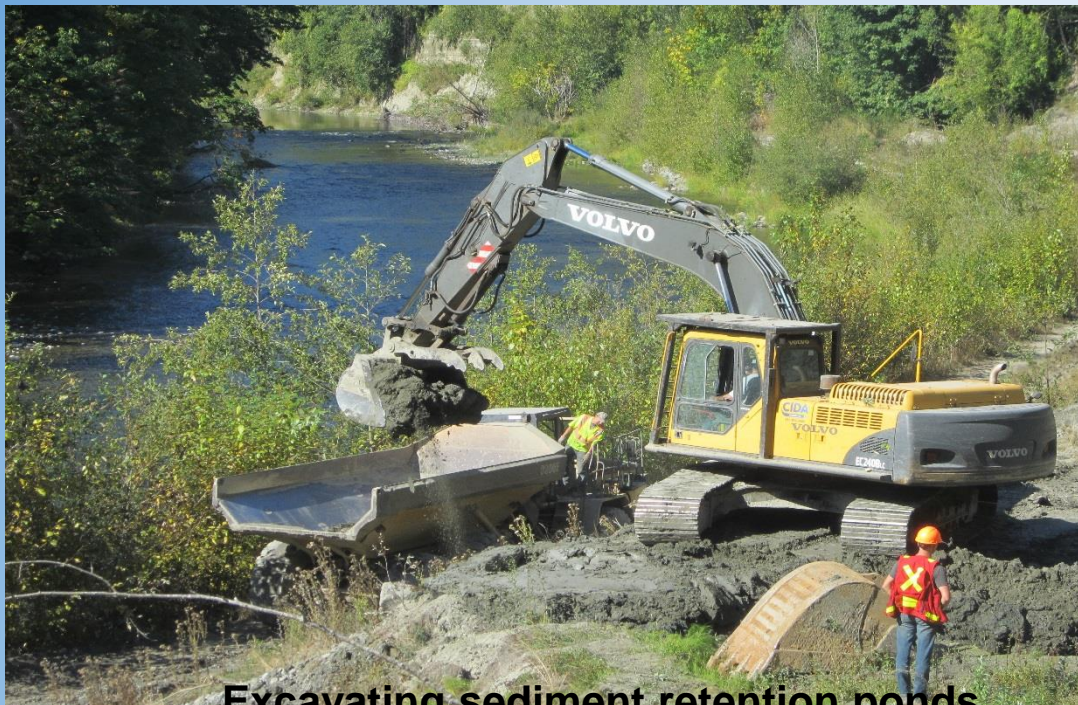
Excavating sediment retention ponds

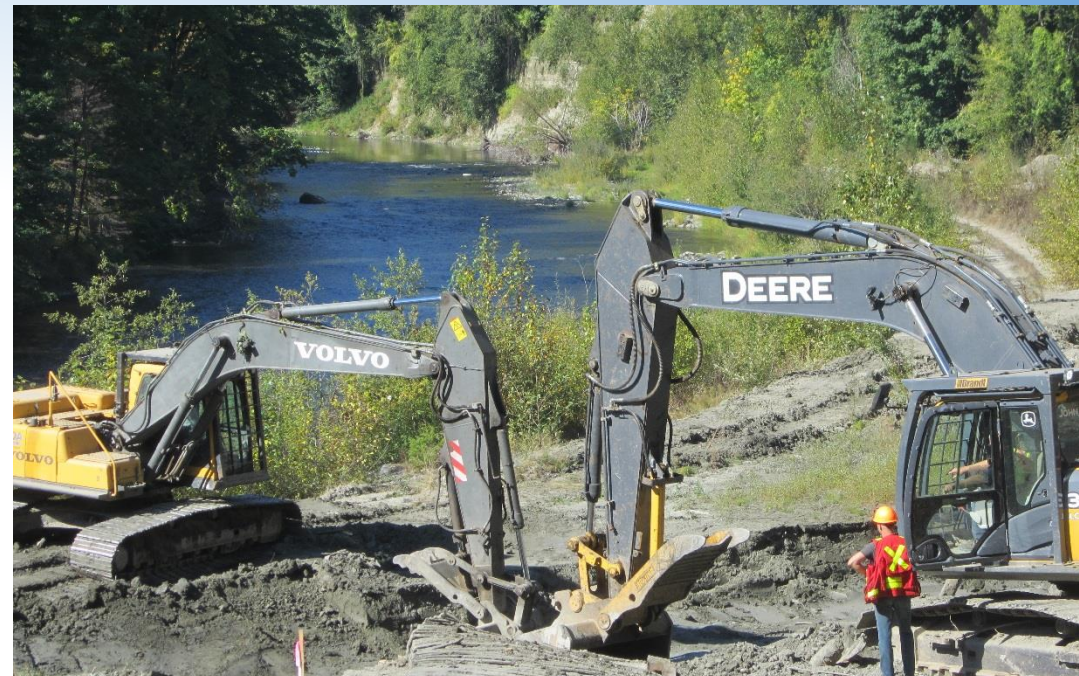
Adding additional height to sediment containment berms

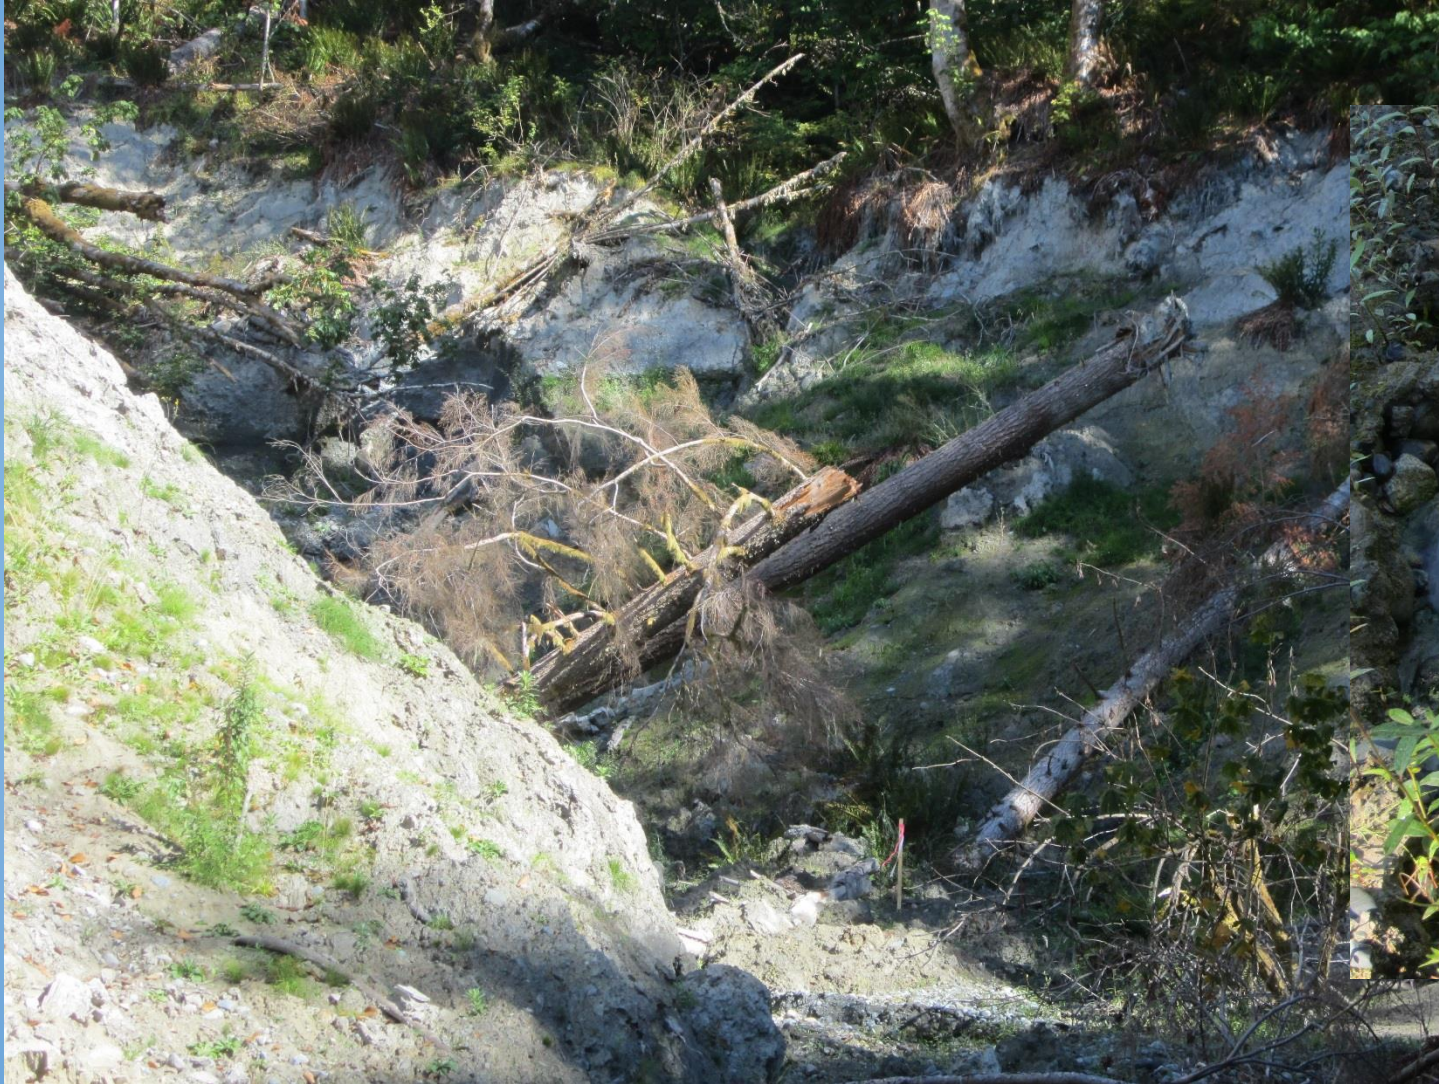
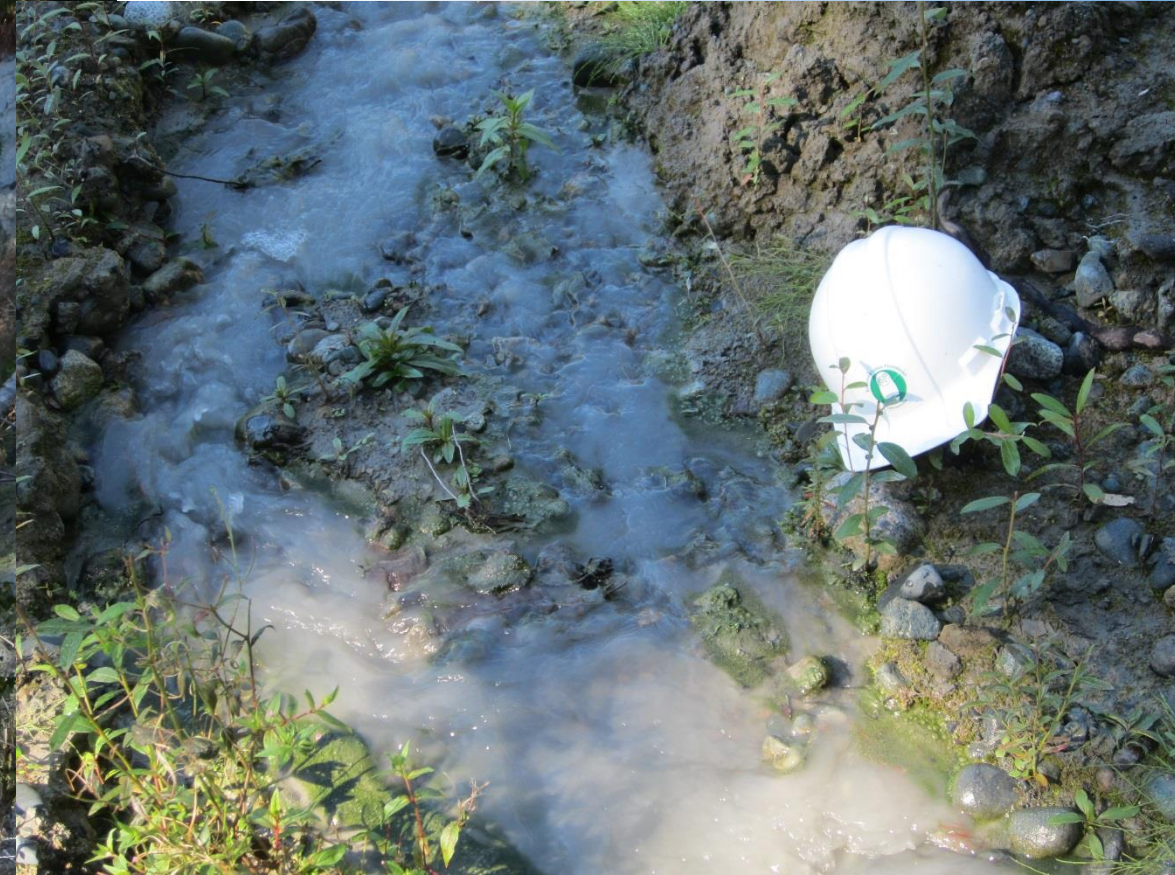
Clearwater Creek Flows Through 'Drain' in Stoltz Bluff Access Road (upstream of Cowichan River)

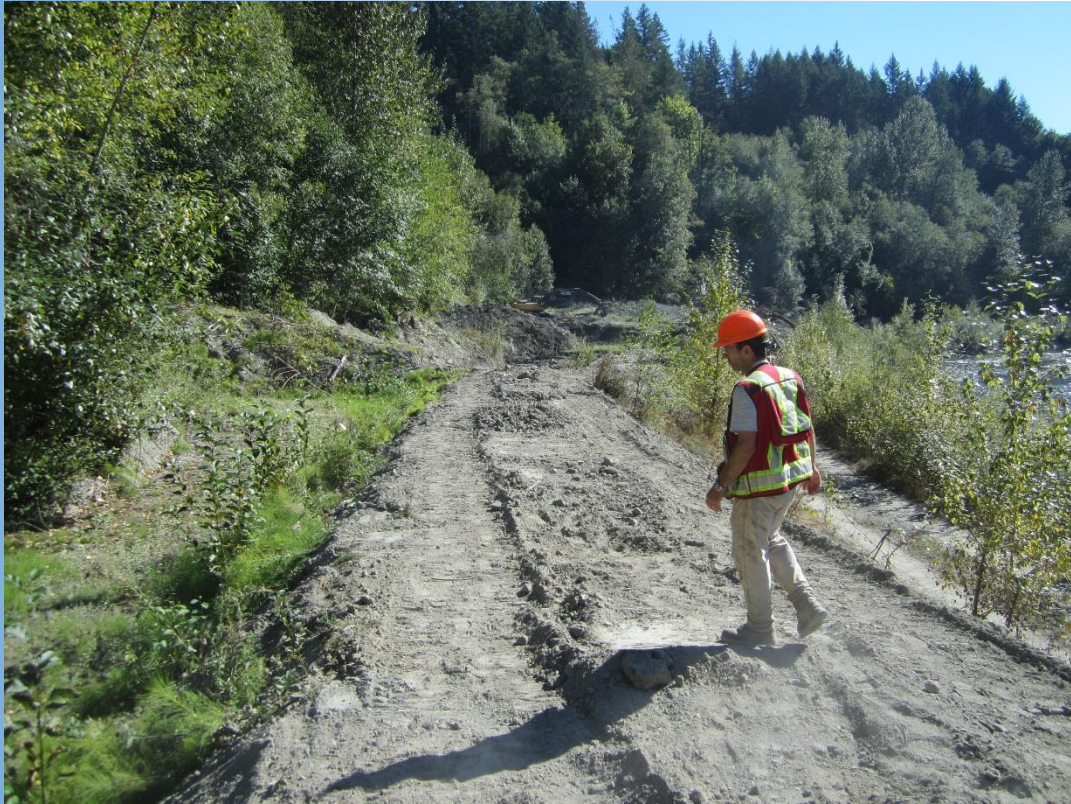
Raised elevation of containment berm

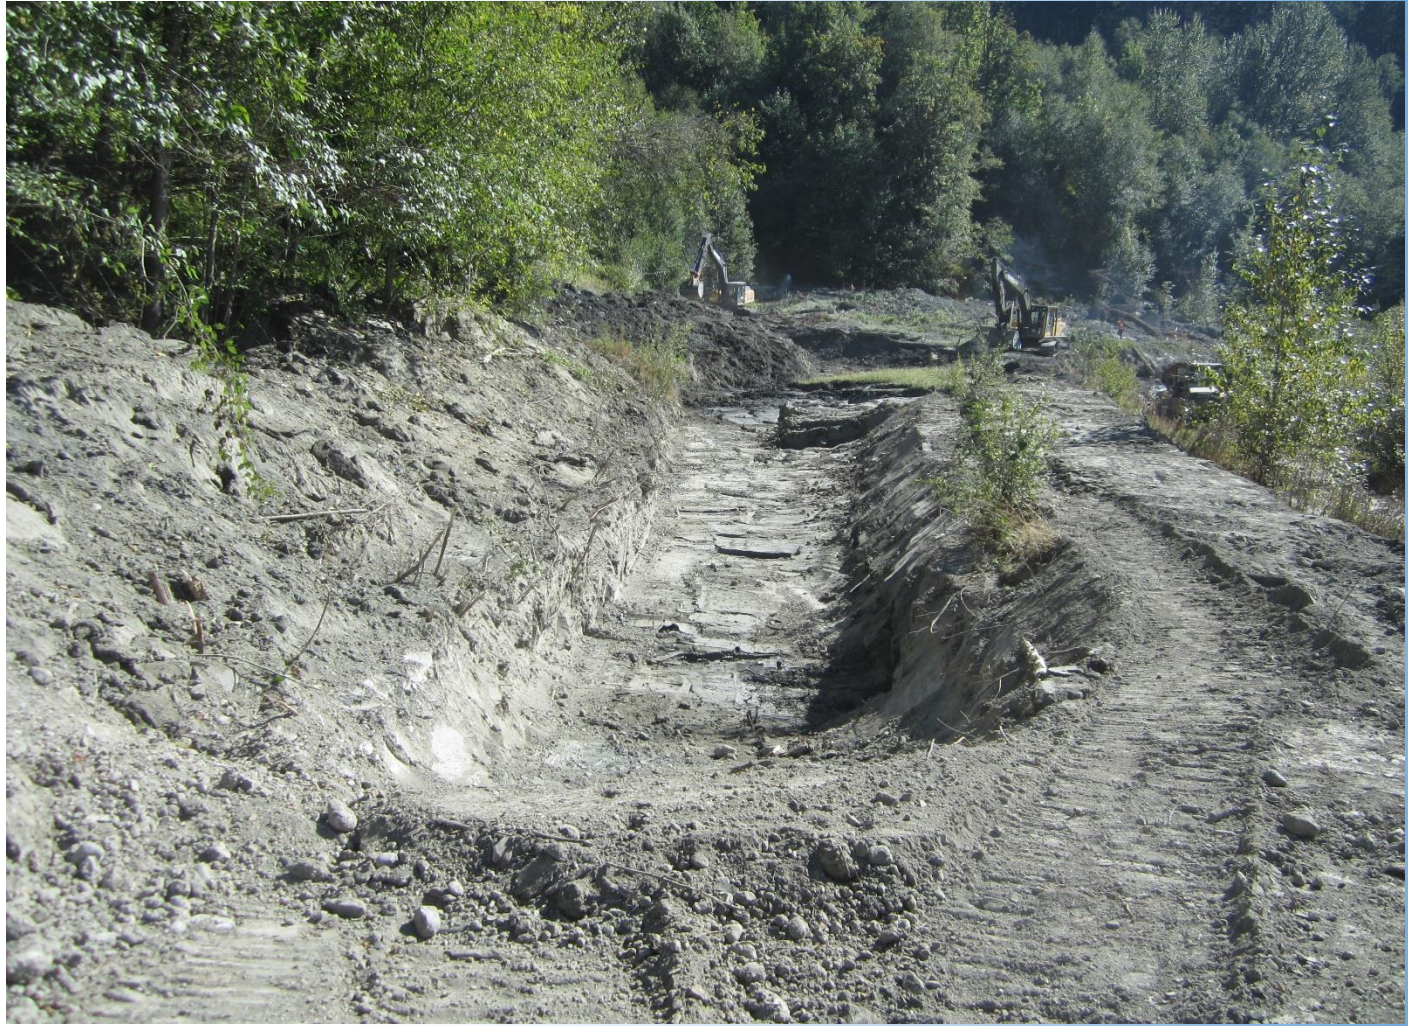
Partially excavated sediment retention pond

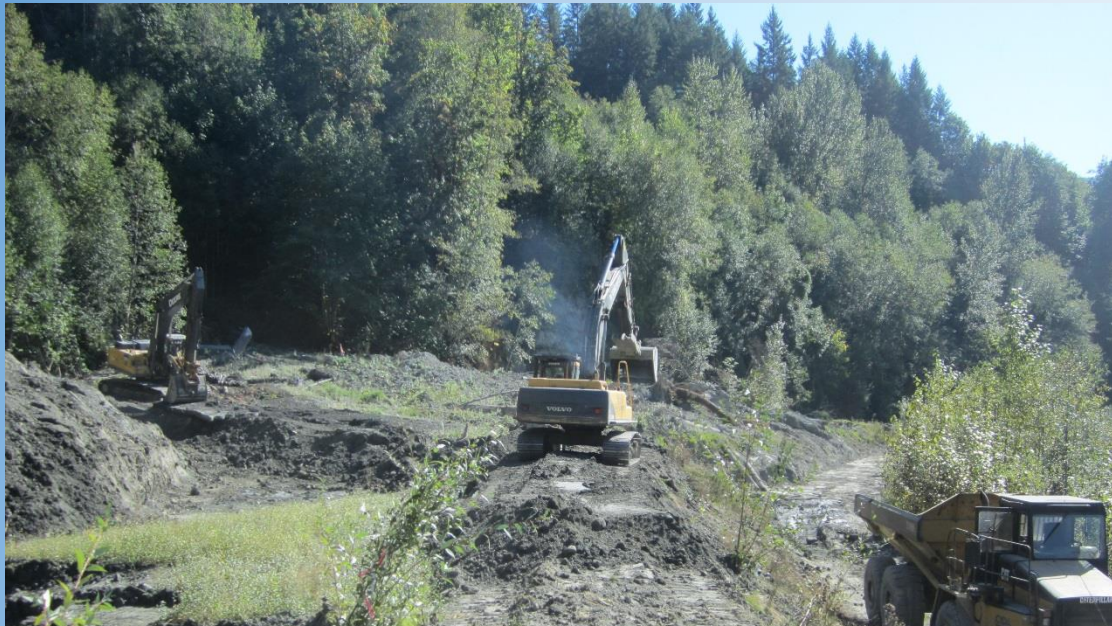
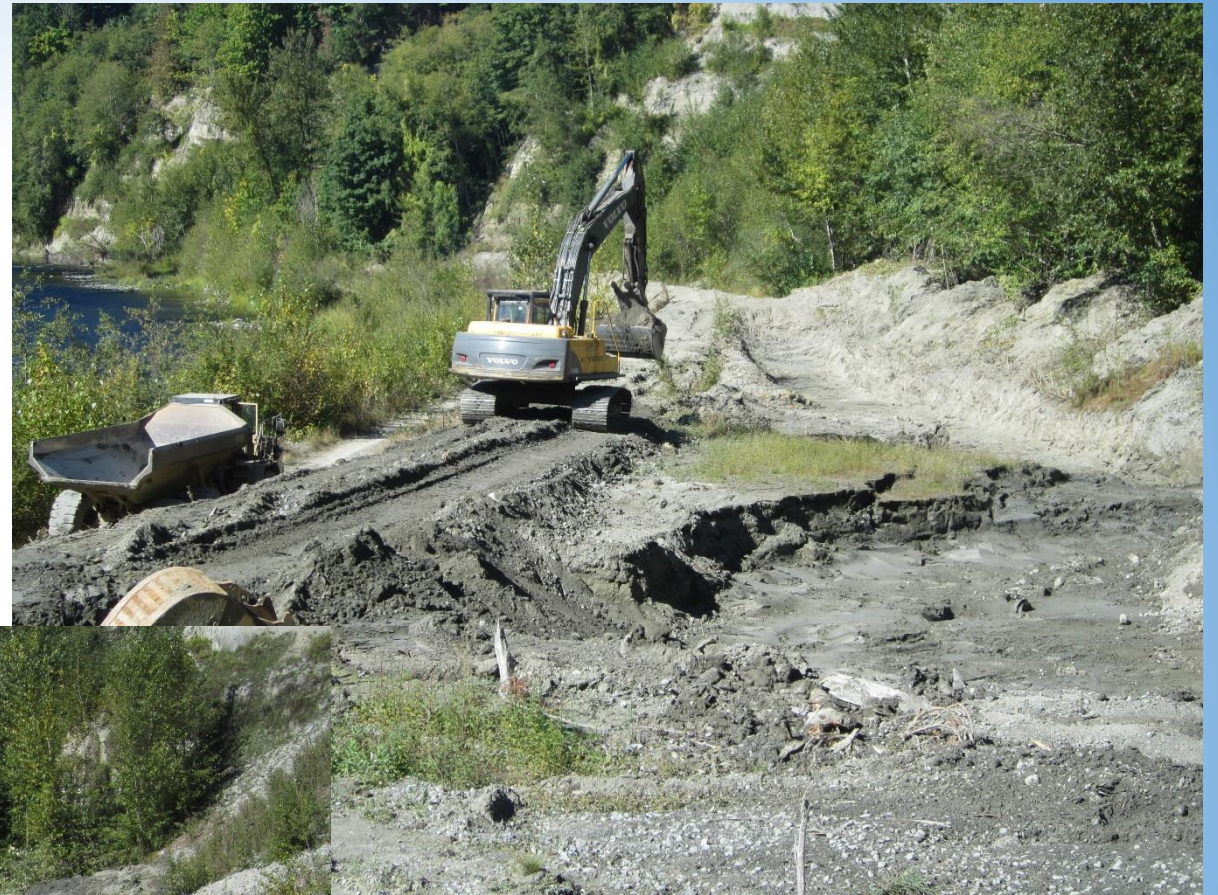
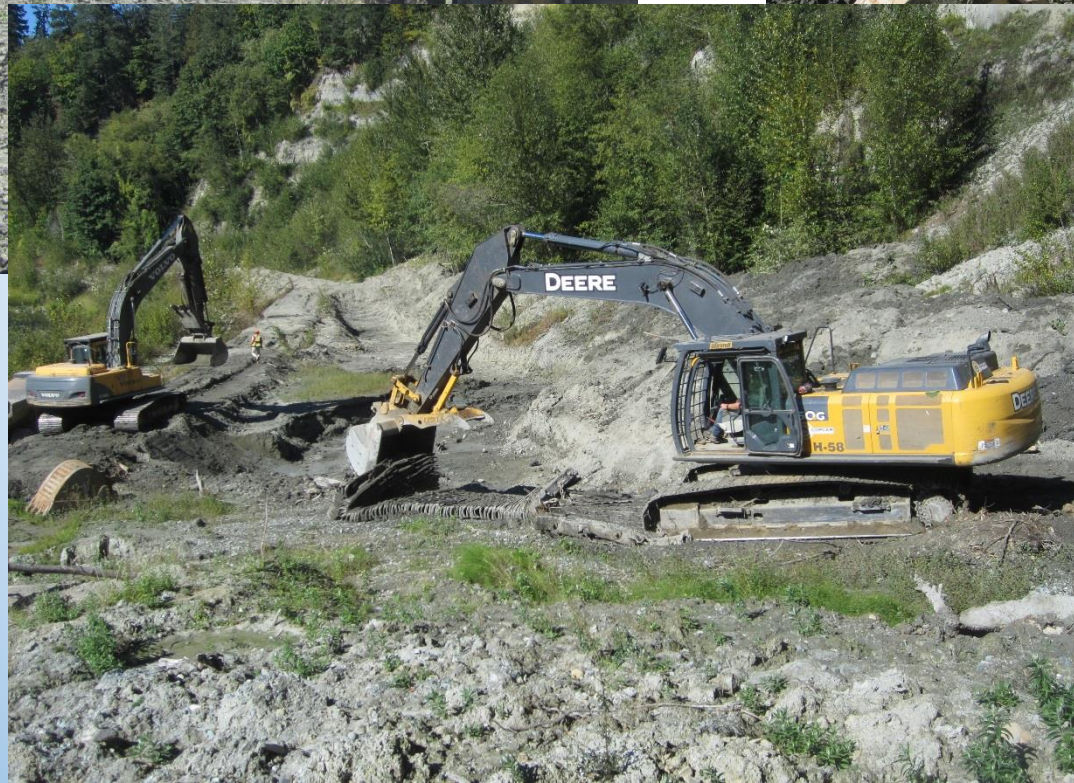
Excavating accumulated sediment and preparing route for overflow channel from Clearwater Creek
